Pickett, Kelm & Associates, Inc.  
Consulting Structural Engineers

## NIXON HIGH SCHOOL GYNASIUM REPAIR

**PROJECT LOCATION:** NIXON, Tx

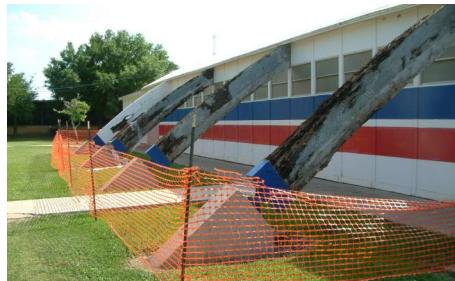
The outer 12'-6" of each arch is exposed to the environment. The exposed ends were originally painted, but later encased in plaster. When the plaster was recently removed, severe decay of the ends of the wooden arches was discovered which threatened the safety of the building.

*Prior to repair*

To repair the building, arches were shored, the rotted exterior ends of the wooden arches were removed and pairs of 4-inch by 16-inch hollow steel tubes, rolled to match the arch curvature, were through-bolted to sound wood inside the building.

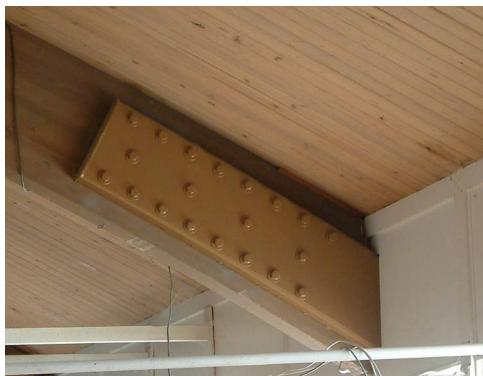
*Connection detail*

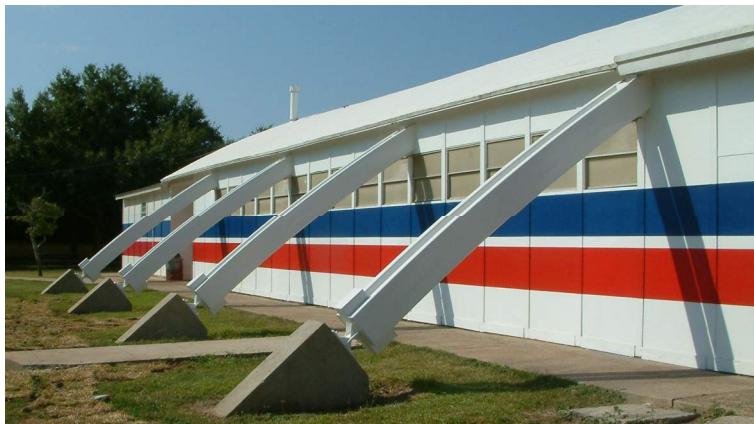
*After repair*
